## INSPECTION REPORT SUMMARY

Date: 01/11/2007  
Summary information for: Mary Homeowner  
For the property located at: XXX Lawson Way Erie, CO

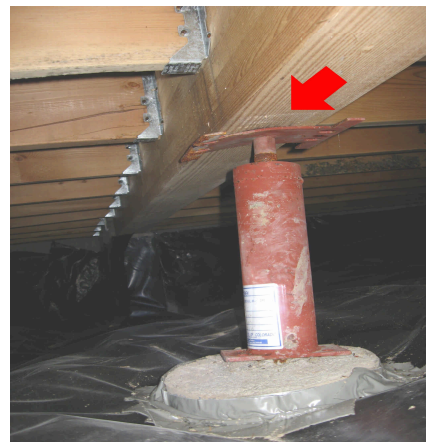
As observed in the sub-floor crawl space, the short metal support posts were not attached at the top plate as is typically required. The top plates were dishing and the wood beam appeared to be crushed at the center of the column. I recommend further inspection by a licensed structural engineer and repairs made as necessary.

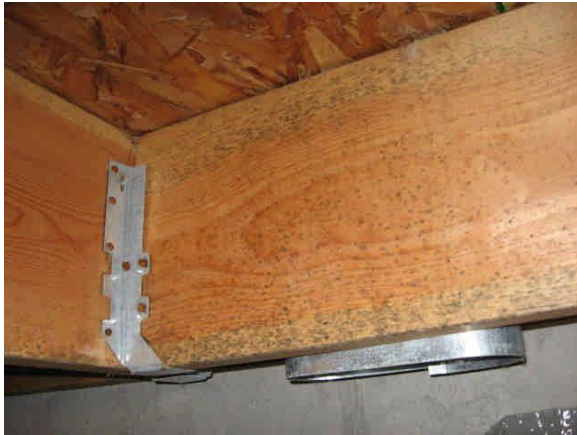
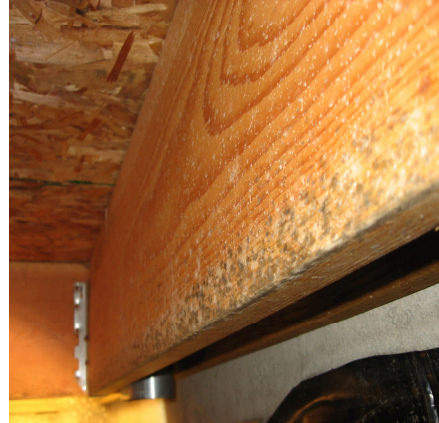
Small gray, black and white spots were observed on many of the wood joists in the right rear area of the sub-floor crawl space. This material appears to be mold. Testing to confirm if this is truly mold is beyond the scope of this inspection. Spores from the mold can enter the living area and, depending on the type of mold, may adversely affect the health of the people living in the house.

**OBSERVATIONS:** Small gray, black and white spots were observed on many of the wood joists in the right rear area of the sub-floor crawl space. This material appears to be mold. Testing to confirm if this is truly mold is beyond the scope of this inspection. Spores from the mold can enter the living area and, depending on the type of mold, may adversely affect the heath of the people living in the house.

I recommend further inspection by an environmental engineer or industrial hygienist and cleaning and repairs performed as recommended.

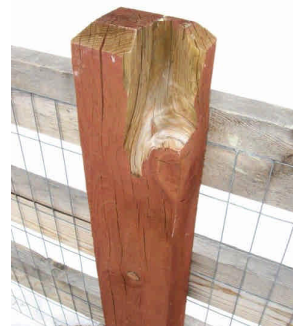
A 3" x 5" chunk was missing out of the top of a fence post at the rear of the property. Correction will require replacement of the post.

- FENCE CONDITION:** A 3" x 5" chunk was missing out of the top of a fence post at the rear of the property. Correction will require replacement of the post.
