INSPECTION REPORT SUMMARY

Inspection Date: 05/03/2007
Summary information for: John & Mary Homebuyer
For the property located at: 12345 Castle Point Lane Castle Rock, CO

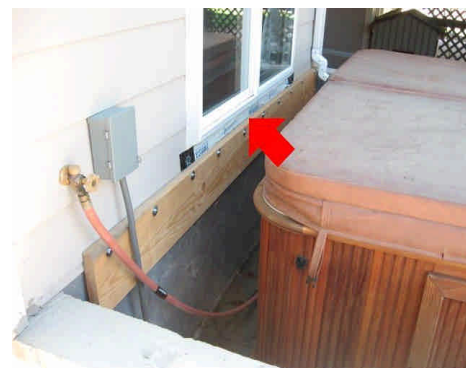
A 6' long x 3" tall opening was observed under the window at the lower level rear right of the house adjacent to the spa. A 2" x 10" board was bolted to the wall directly below this opening. I was unable to determine the reason for these conditions. The opening is a potential water entry area into the wall

and should be sealed immediately. I recommend asking the current owner about their plans for this area.

A 6' long x 3" tall opening was observed under the window at the lower level rear right of the house adjacent to the spa. A 2" x 10" board was bolted to the wall directly below this opening. I was unable to determine the reason for these conditions. The opening is a potential water entry area into the wall and should be sealed immediately. I recommend asking the current owner about their plans for this area.

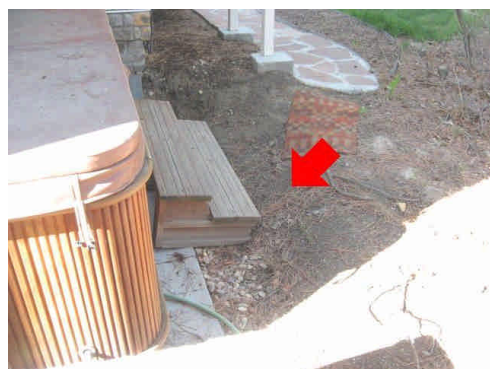
The grading at the rear of the concrete pad for the spa was not properly sloped away from the pad. A bucket with holes drilled in the sides was partially buried in the corner to capture the water in this area. It is proper practice for the grading to slope away from concrete surfaced. I recommend correction as necessary.

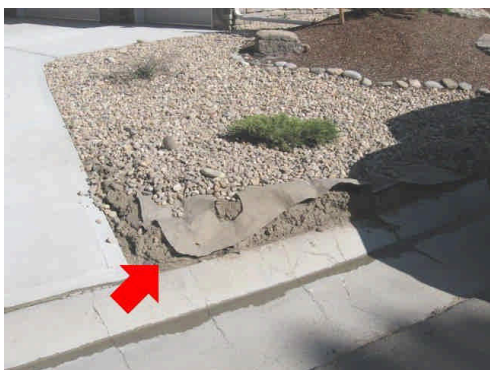
The landscaping was disturbed at the right front corner of the driveway. Some repair is necessary.

Metal edging has been used in the landscaping. This edging is sharp and can be a hazard to people and pets if they step or fall on the edging. Consideration should be given to replacing this edging.

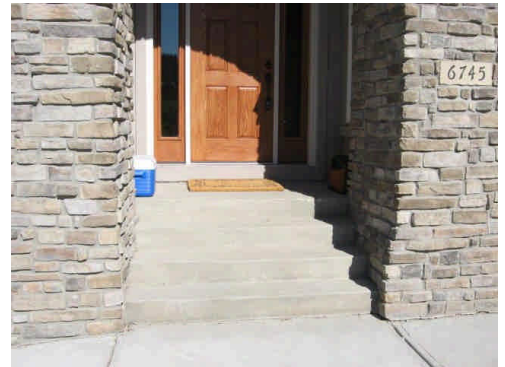
No handrail is installed on the 4 riser stairway leading to the front porch. Current building standards for new homes require a railing on any stairway with 4 or more risers. This is a potential safety issue and should have been installed when this house was built.

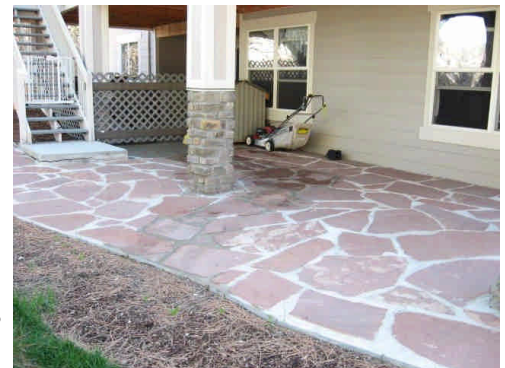
The patio section under the deck is not properly sloped to allow surface water to drain from the patio area. This is an inconvenience issue that it not easily remedied.

Minor cracking was observed in the mortar of the flagstone patio grout joints. The proper installation of flagstone with concrete grout joints is on a concrete surface. It appears that this flagstone has been installed directly on the soil or sand bed. Expansion and settling of the soil has and will continue to caused the grout to crack and deteriorate over time. A proper installation would have been to install sand or gravel in the grout joints rather than mortar.

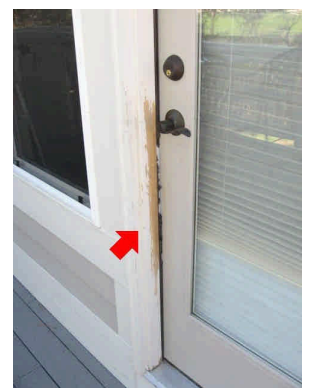
Significant scratching (probably from a dog) was observed on one side of the door frame at the left side of the deck. The weatherstripping in this area was damaged and partially missing. Replacement of the weatherstripping and repair/re-painting of the door frame is needed.

DOOR CONDITION: Significant scratching (probably from a dog) was observed on one side of the door frame at the left side of the deck. The weatherstripping in this area was damaged and partially missing. Replacement of the weatherstripping and repair/re-painting of the door frame is needed.

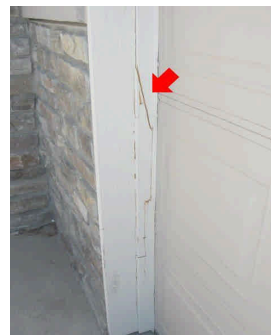
The wood trim around the large garage door is damaged and scratched in several areas. A 3" long crack and damage was observed on left side. Repair will require replacement of the cracked board, filling the scratches and re-painting.

CONDITION: The wood trim around the large garage door is damaged and scratched in several areas. A 3" long crack and damage was observed on left side. Repair will require replacement of the cracked board, filling the scratches and re-painting.

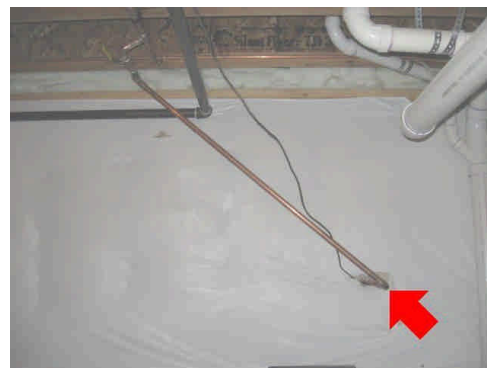
No bleed valve was observed on the low section of sprinkler pipe in the basement for draining the water out of the system in preparation for freezing weather. I recommend that a proper bleed valve be installed in the lowest section of pipe by a professional plumber or sprinkler system contractor.

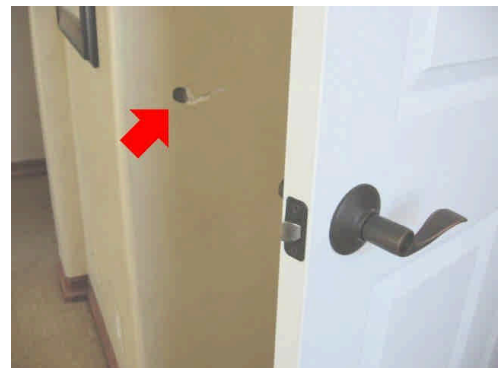
An approximate 4" x 1" hole was observed in the wall behind the master bedroom entry door caused by the doorknob breaking through the wall. Repair and re-painting is necessary.
